## **Intrusive Inspection Report**

Re: Chronic water leak

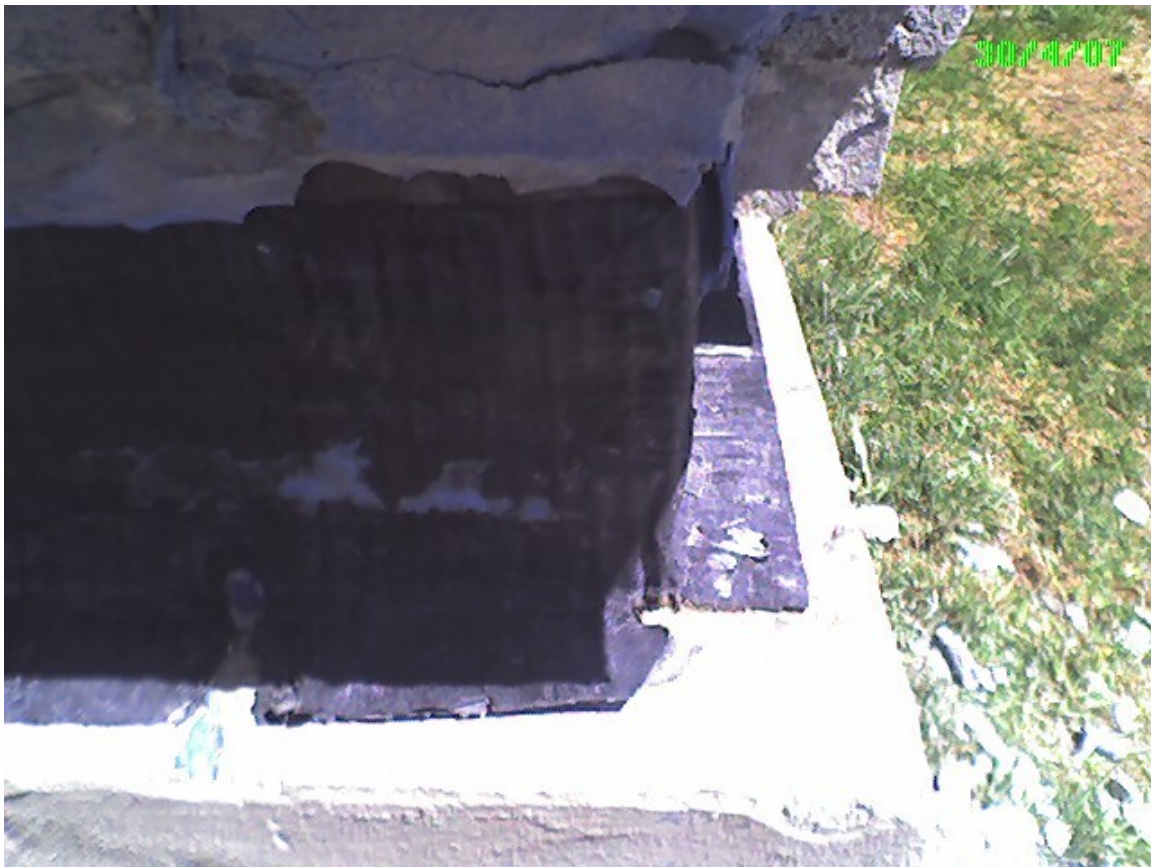
1. The most apparent problem was that the flashing did not extend past the exterior of the foundation. It was at least an inch from the outside of the foundation. This is a building code infraction. A min of  $\frac{1}{4}$ " projection past the exterior of the foundation wall is required (9.20.13.6). See picture below.

2. The next observation was the destruction of the flashing by drilling out the weep holes by the builder as an attempted repair of the problem. (See first picture) The weep holes are required by code (9.20.13.8) to allow moisture to escape the wall cavity to the exterior of the home. However, the holes on this house are poorly formed and blocked with mortar. This is why they were drilled out by the builder. This process actually did more damage than good by destroying the flashing material.

It is the Builders responsibility to install the flashing to code. It should extend ¼" past the foundation wall when the job is complete. In circumstances where there is no brick ledge at the top of the foundation wall this becomes critical.

Clean repair area well. Seal the original flashing with tar where the flashing meets the concrete, paying particular attention to the corners and any cut/damaged areas; coat it well. Use peel and stick flashing material (Blue-Skin or equivalent) and apply it over the existing flashing, making sure to lap it under the building paper. It must extend a minimum of 1/4" past the exterior edge of the foundation wall. Seal it thoroughly to the existing flashing material.

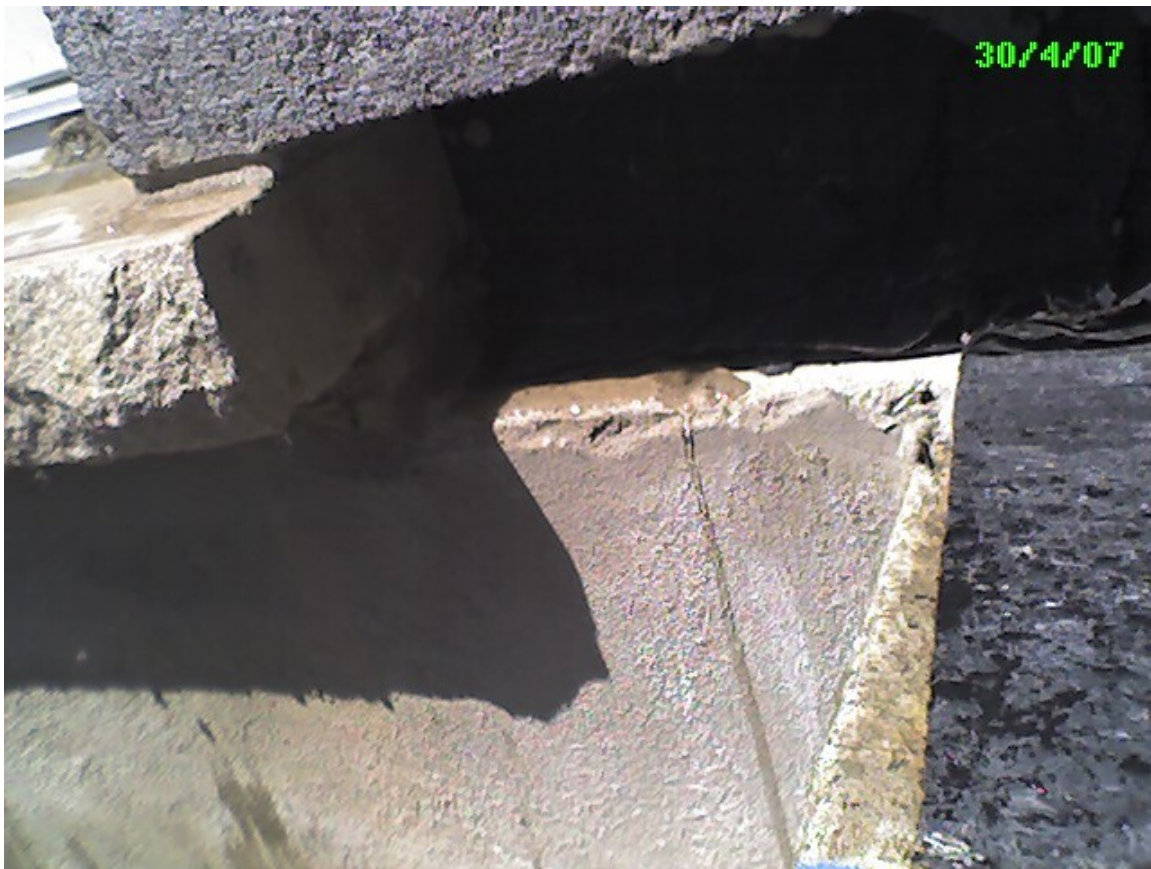
The importance of this becomes apparent when I did the water test. Using just a water hose I ran water into the air space, behind the brick, through the weep holes above the patio door. After only a couple of minutes, water started to seep into the suspect area. It ran down the exterior of the flashing (as it should) and began to puddle on the foundation wall just past the limit of the flashing. See picture below.

The foundation wall is not perfectly formed at the top, and in the suspect area, slopes to the inside. As a result, water did seep under the flashing and back into the house, rendering the flashing useless.

3. The flashing material was cut to go around the corner, providing an area without any protection. This is evident in the above picture.
