## **Intrusive Inspection Report**

Re: Chronic water leak

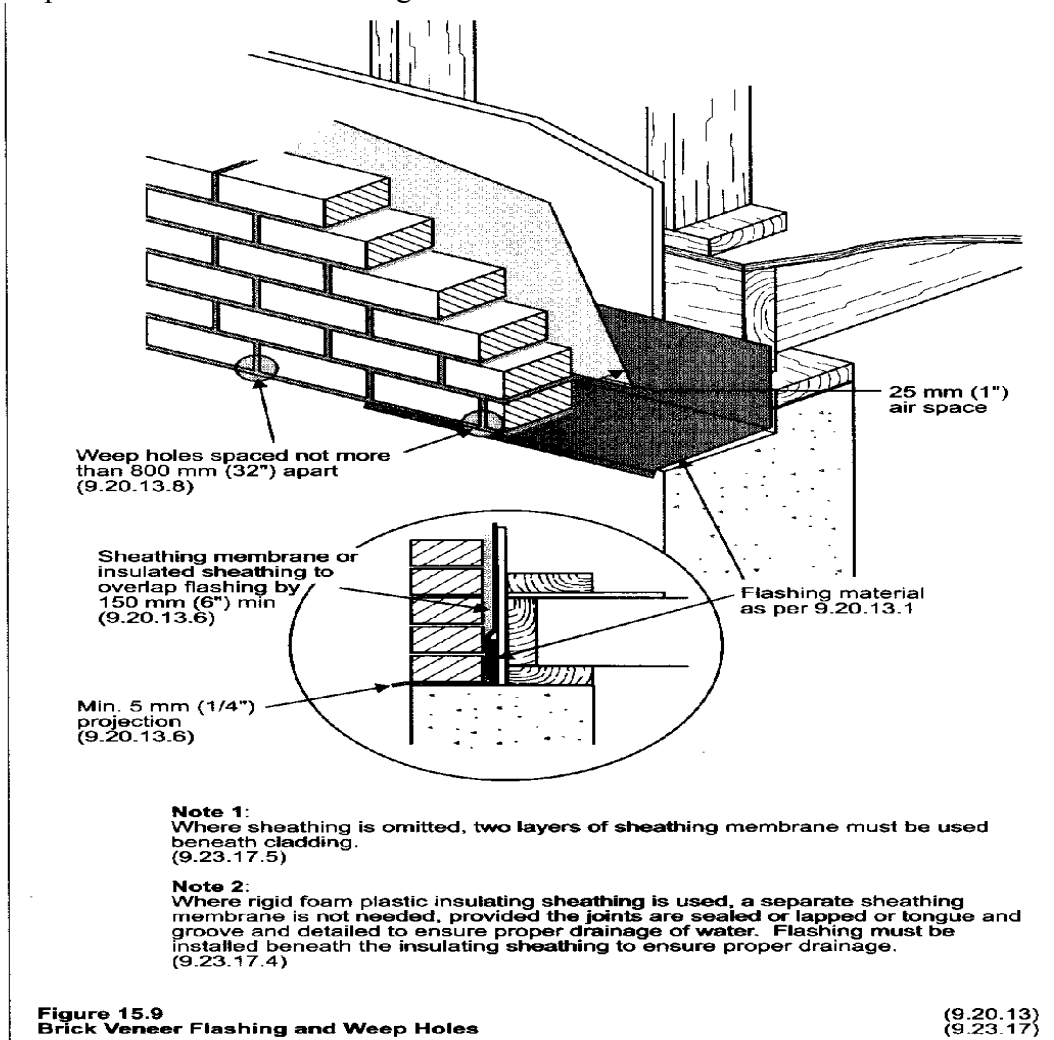
Excerpt from the Ontario Building Code.

It is the Builders responsibility to install the flashing to code. It should extend ¼" past the foundation wall when the job is complete. In circumstances where there is no brick ledge at the top of the foundation wall this becomes critical.
